— USS GETTYSBURG (CG-64) —
SEMAT I SHELL CONDITION ASSESSMENT
SURVEY
INTERIOR AREAS
12/03/01 TO 12/14/01

PREPARED BY
SUPERVISOR OF SHIPBUILDING CONVERSION
AND
REPAIR USN
PORTSMOUTH, VIRGINIA
12/14/01

SHELL CONDITION ASSESSMENT SURVEY INTERIOR AREAS TABLE OF CONTENTS

USS GETTYSBURG (CG-64)
SHELL CONDITION ASSESSMENT OF SURVEY SUMMARY, INTERIOR AREAS

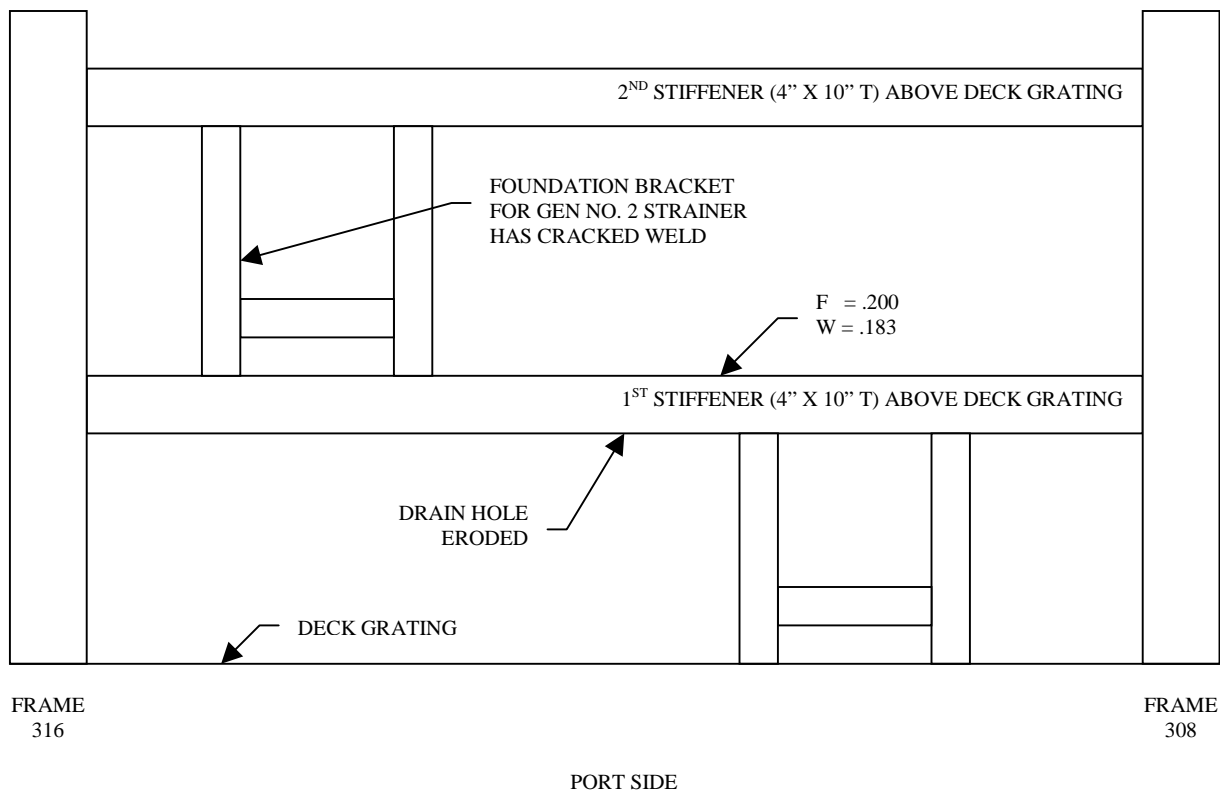
USS GETTYSBURG (CG 64)
MAIN ENGINE ROOM NO. 2
(5-300-0-E)

FOUNDATION BRACKET FOR GEN NO. 2 STRAINER BETWEEN FRAMES 308 – 316 HAS A CRACKED WELD

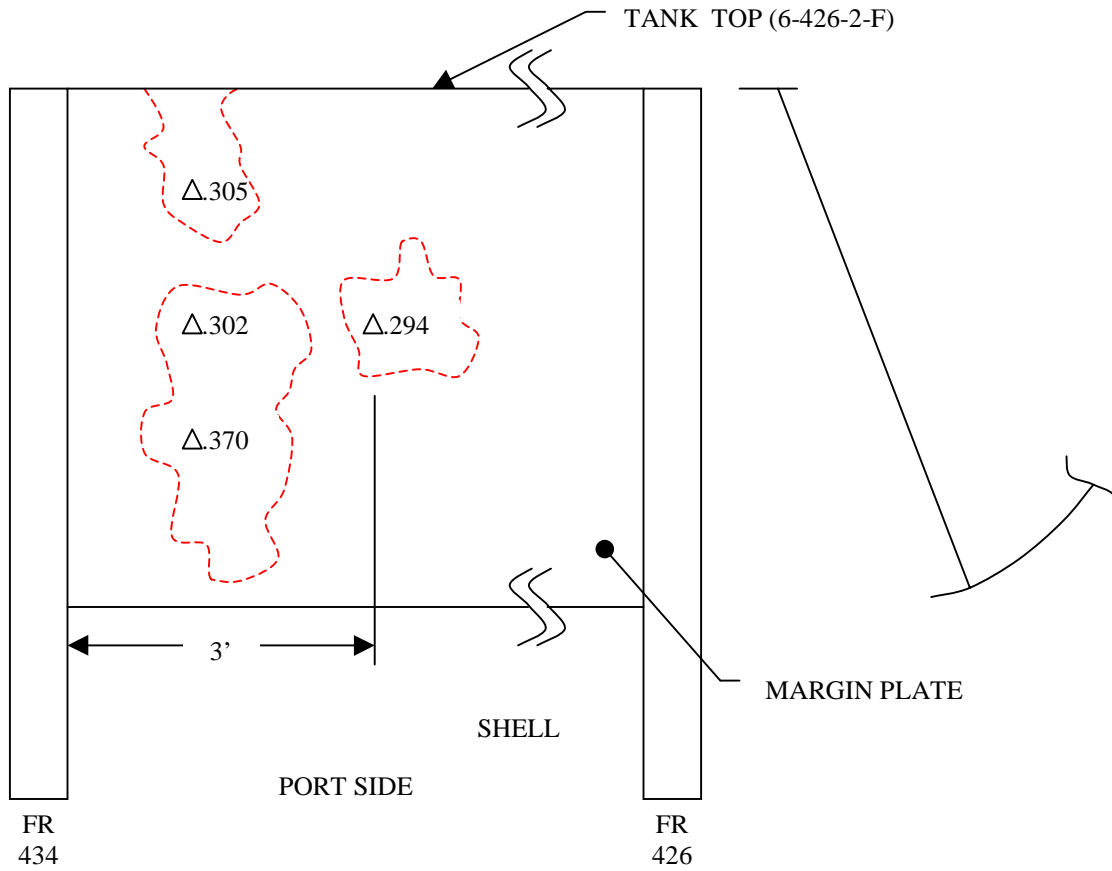
USS GETTYSBURG (CG-64)
LANDING FORCE STRM
(3-426-2-A)

AREA SHOWS LOOSE AND FLAKING SCALE
